# Smoke and Dye Testing Summary

## High Level Sewershed

Test ID	Test Type	Date Inspected	Company / Super.	Blower MH	Ground Condition	Notification Made?	Total Length
S1028-045	Smoke	9/5/2008	ADS/TM	S13GG1002MH	Dry	Yes	995.23

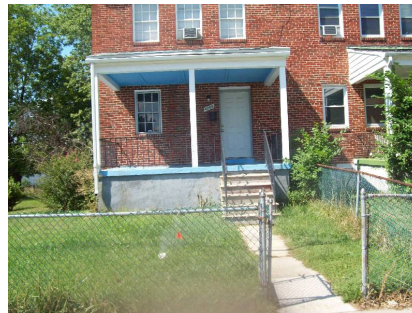
**Picture** \S1028-045-OB02-P01.jpg

**Comments** Smoke from cleanout in front yard. 4200 Pimlico Rd.

**Comments** Front of house, 4200 Pimlico Rd.
